Harbourfront Centre Water's Edge Revitalization Project Value Engineering Study

Presented by: Andrew Hachborn, M.Sc., P.Eng., AVS
Marshall Macklin Monaghan Limited

VE Study was carried out by the
Toronto Waterfront Joint Venture for
the Toronto Waterfront Revitalization
Corporation

It involved work planned for York
Quay, the first phase of reconstruction
of the Toronto Waterfront

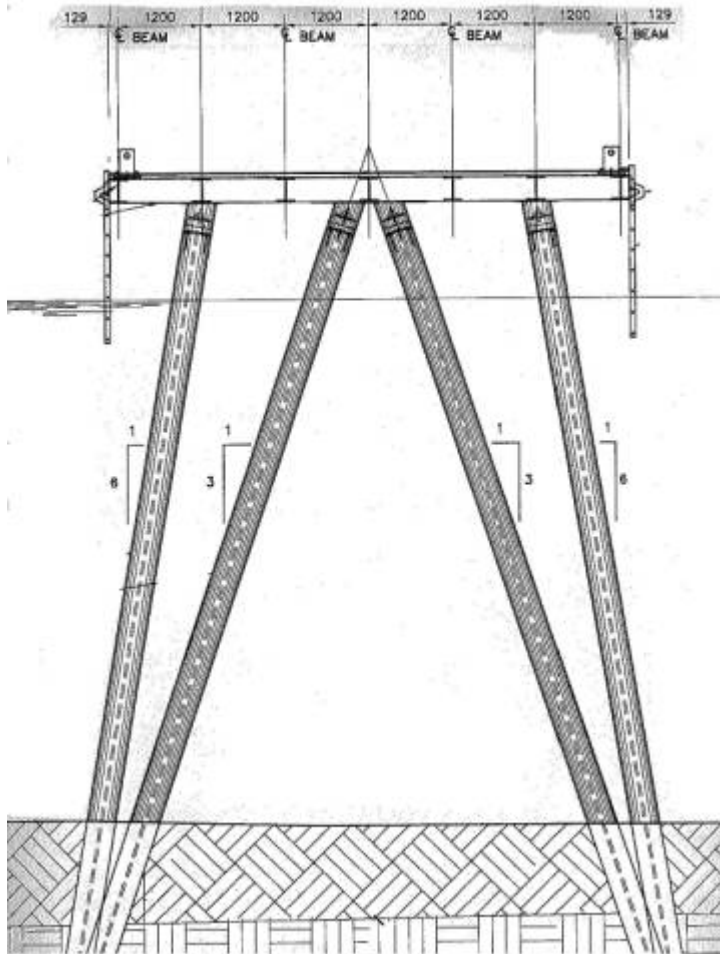
Finger Piers – Base Case

- Piles driven open-ended, cut to exact height, material removed from interior of piles
- Tension anchor installed into bedrock through end of pile, grouted and pile filled with concrete
- Steel framework welded to bents constructed of 3 or 4 tension/compression piles
- Wood deck fastened to structural steel framework

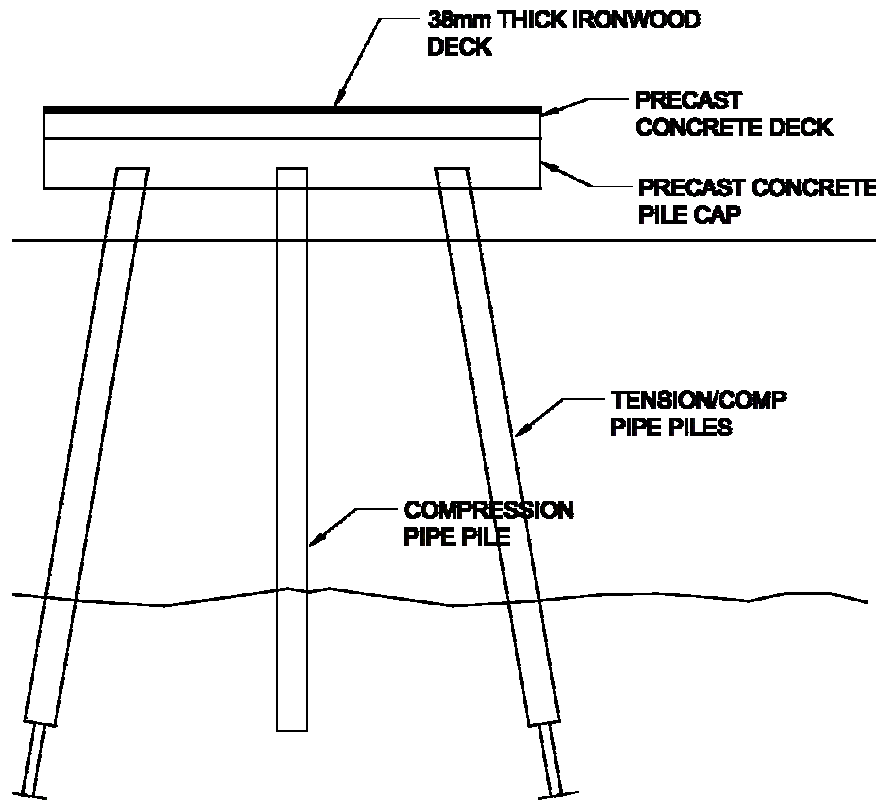
Selected Finger Piers Alternative

- Piles driven closed-ended
- 2 tension/compression pipe piles and one compression pile per bent
- Tension anchor installed into bedrock through end of pile, grouted and pile filled with concrete
- Wood deck fastened to non-bio-degradable nailing strips, embedded in precast concrete deck structure

- Although normally a heavier structure results in a more expensive foundation, in this case a heavier structure reduced the number of expensive tension piles
- Cost savings did not include the cost savings due to the recent significant increase in price of steel

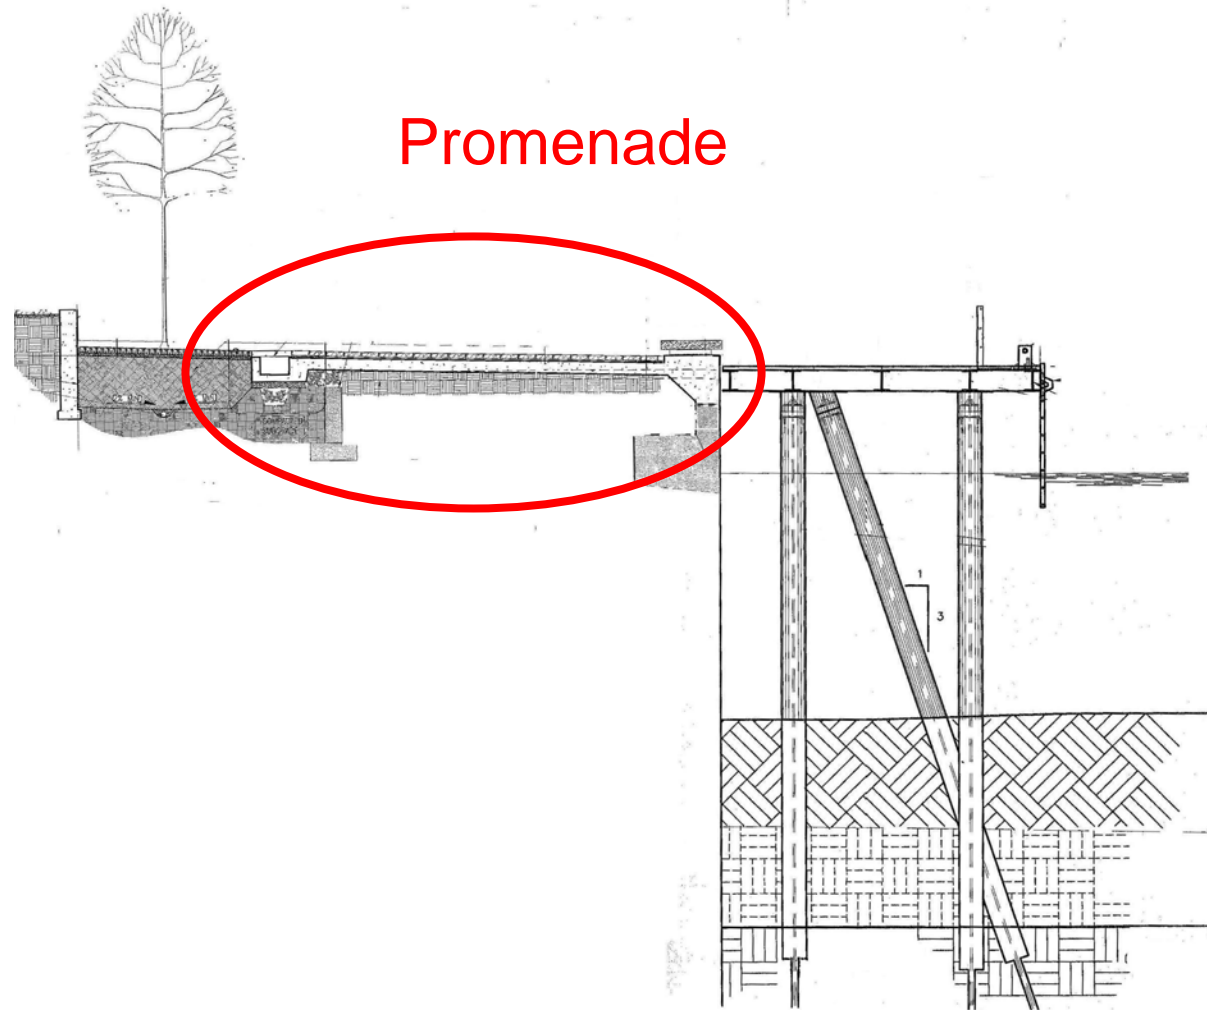
Boardwalk – Base Case

- Constructed on grade with lakeshore edge supported on existing crib wall
- Designed to bridge over any localized loss of material/ support due to failure of crib wall

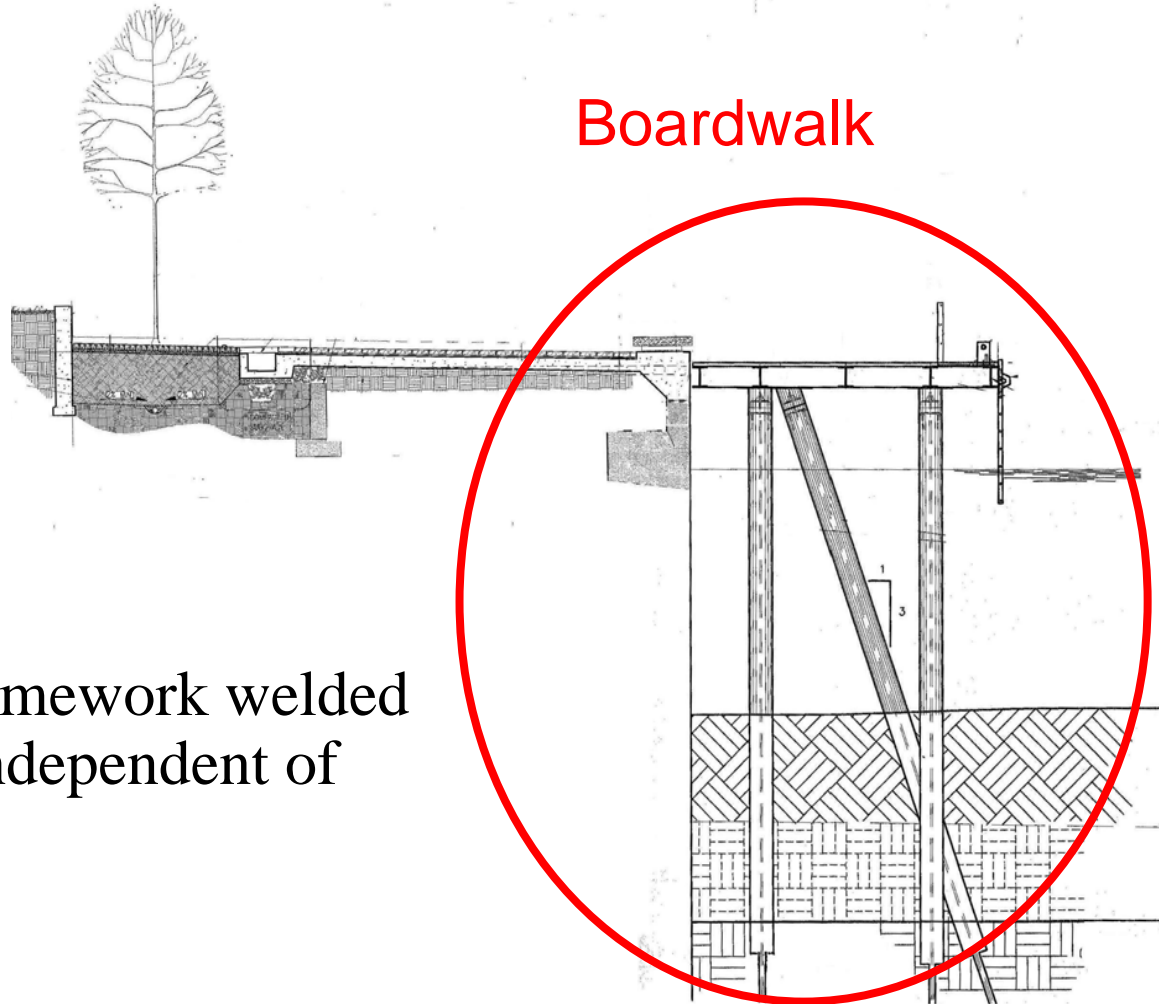
Boardwalk – Base Case

- 3 tension/compression piles driven open-ended and cut to exact height, material removed, tension anchor installed into bedrock, grouted and filled with concrete
- Structural steel framework welded directly to piles, independent of existing wall
- Wood deck

- Any movement of the front part of the crib wall impacts the structural integrity of the promenade slab resulting in movement or rotation of the complete slab.
- During repair of crib wall heavy equipment will not be able to work supported on the promenade slab.
- New 50 year lifespan structure will be supported on structure with 20 year remaining life (some movement will most likely occur prior to 20 years)

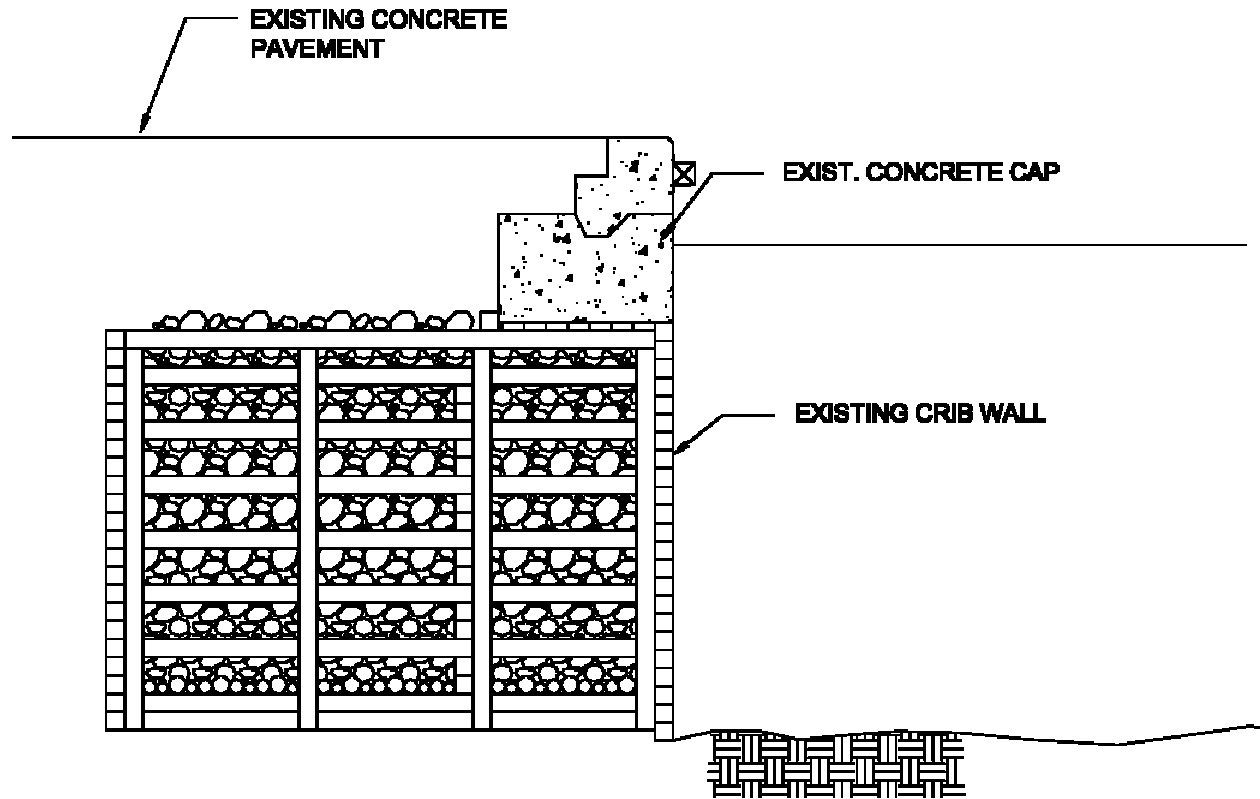
ORIGINAL CONFIGURATION

Selected Boardwalk Alternative

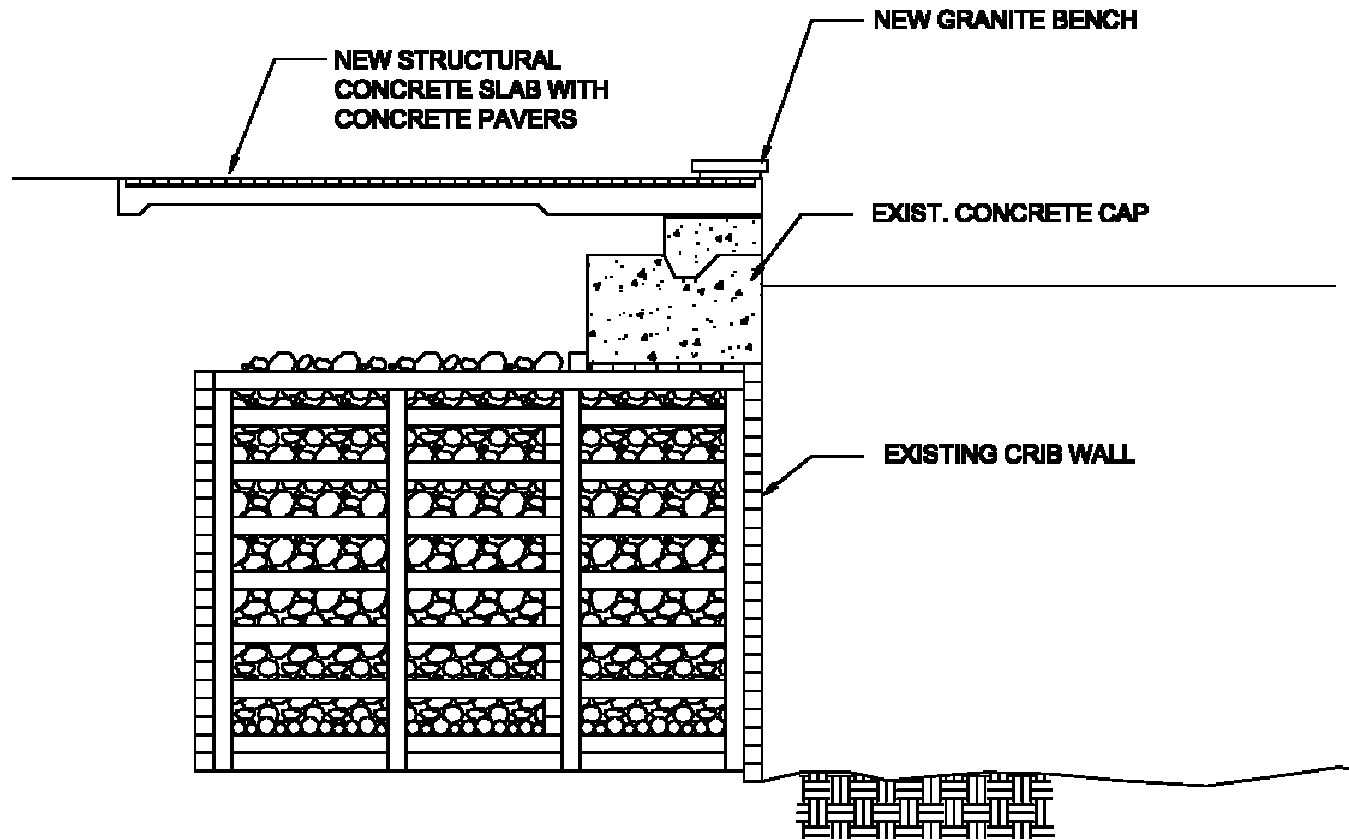
PROPOSED PROMENADE CONFIGURATION

Selected Boardwalk Alternative

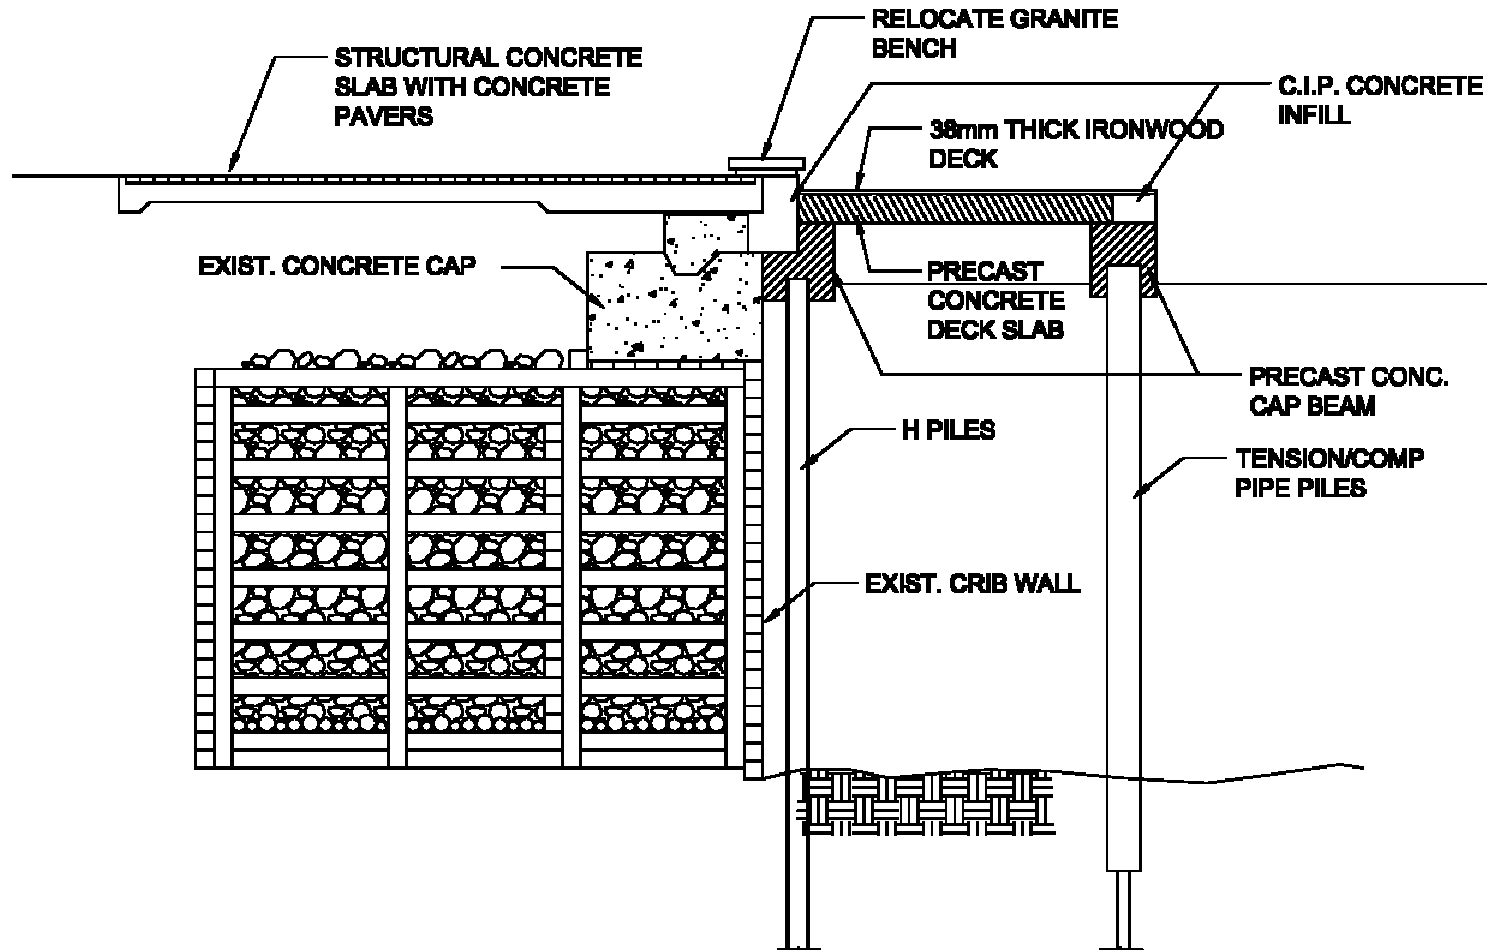
PROPOSED BOARDWALK CONFIGURATION

Selected Boardwalk Alternative

- Base case engineering design avoided the use of the existing crib wall for support of the new boardwalk due to its poor condition. Failure of the crib wall would have caused partial failure of the new promenade and require maintenance.
- VE Study determined that some originally imposed constraints did not apply.
- VE Study demonstrated that there was no additional cost to design the promenade and boardwalk to avoid the effects of failure of the crib wall.
